**CORONERS COURT
OF NEW SOUTH WALES**

Inquest:	Inquest into the death of Alan Beeby
Hearing dates:	12 - 14 September 2023
Date of findings:	14 September 2023
Place of findings:	Newcastle
Findings of:	Magistrate Kennedy Deputy State Coroner
Catchwords:	CORONIAL LAW – maritime safety, safety standards for recreational vessels, certification of recreational vessels, product warnings for recreational vessels, code of conduct for boat brokers, Boating Industry Association, Australian Recreational Boating Safety Committee, European Union design standards for recreational vessels, ISO Standards for recreational vessels, Australian Builders Plate standard, EPIRB functionality, Halvorsen motor yachts, certification of imported recreational vessels
File number:	2020/100125145
Representation:	Counsel Assisting the inquest: Mr Callan O'Neill of Counsel instructed by Mr Paul Armstrong of the NSW Crown Solicitors Office. Mrs Lorraine Beeby, Senior Next of Kin: Mr Gordon McGrath of Counsel instructed by Mr Julien Castaldi of Sparke Helmore Lawyers.

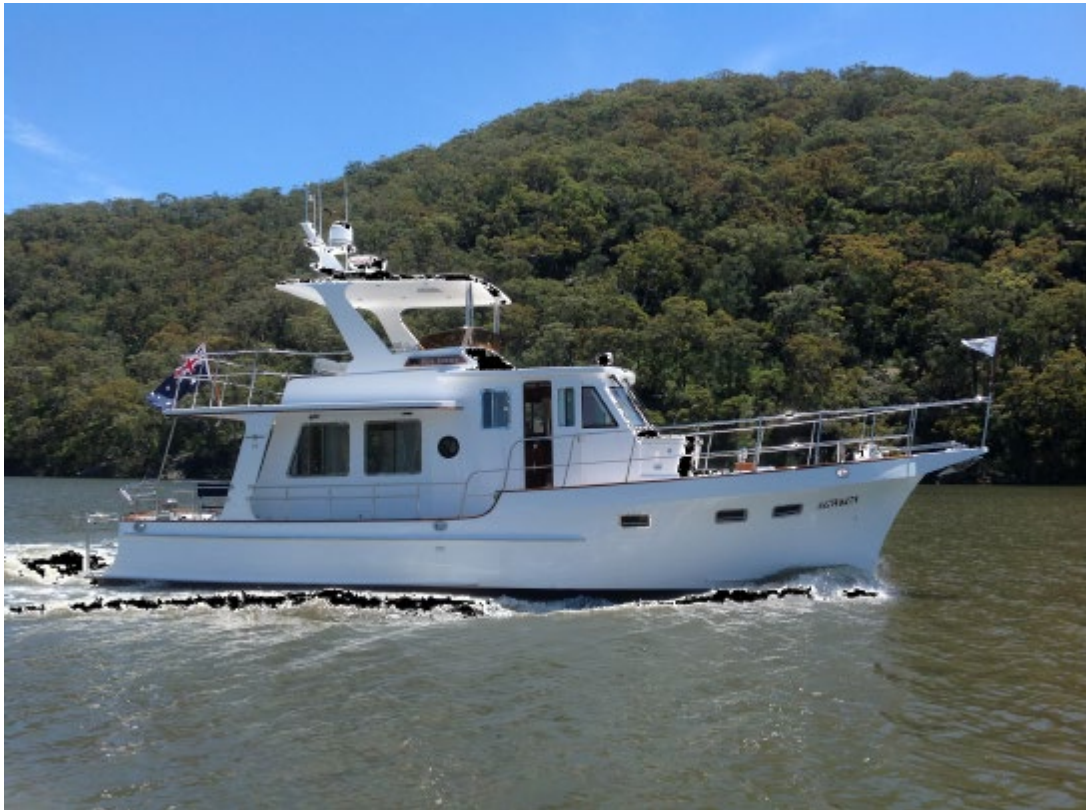
The Peta Emma before being wrecked on Balmoral Beach

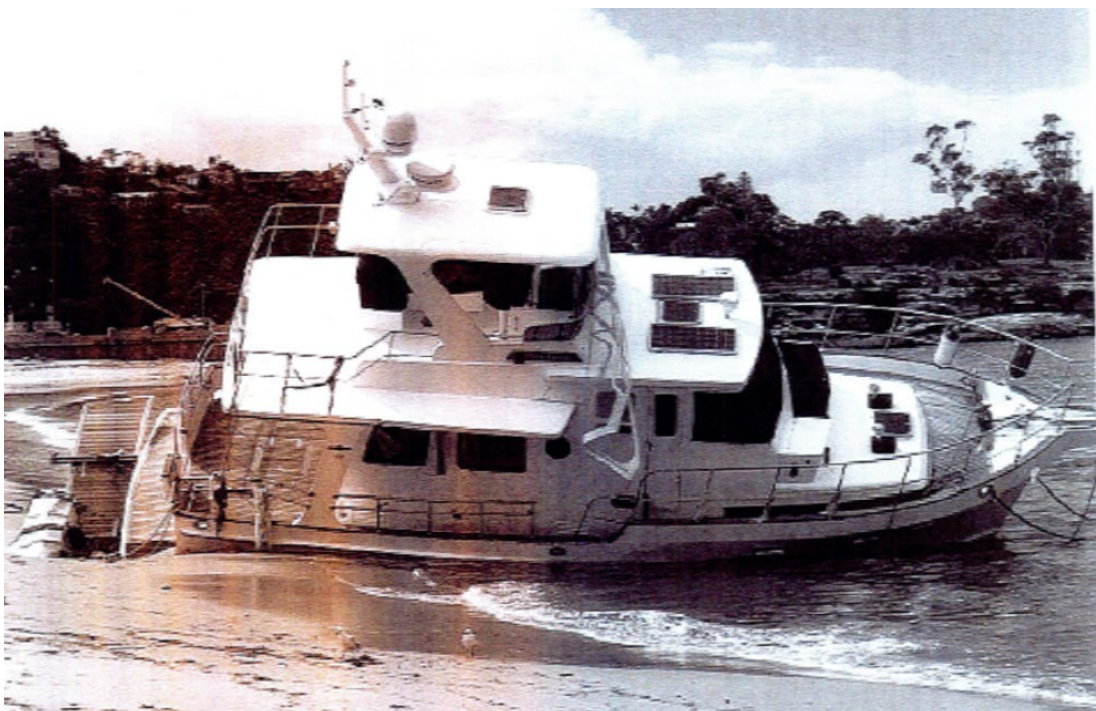
The Peta Emma on Balmoral Beach in February 2020
